Natural Surroundings LLC

Wetland and Listed Species Report for:

19341 Slater Rd, North Fort Myers, FL, 33917
Strap # 07 43 25 00 00006 0040

Re: 19341 Slater Rd Wetland and Listed Species Report

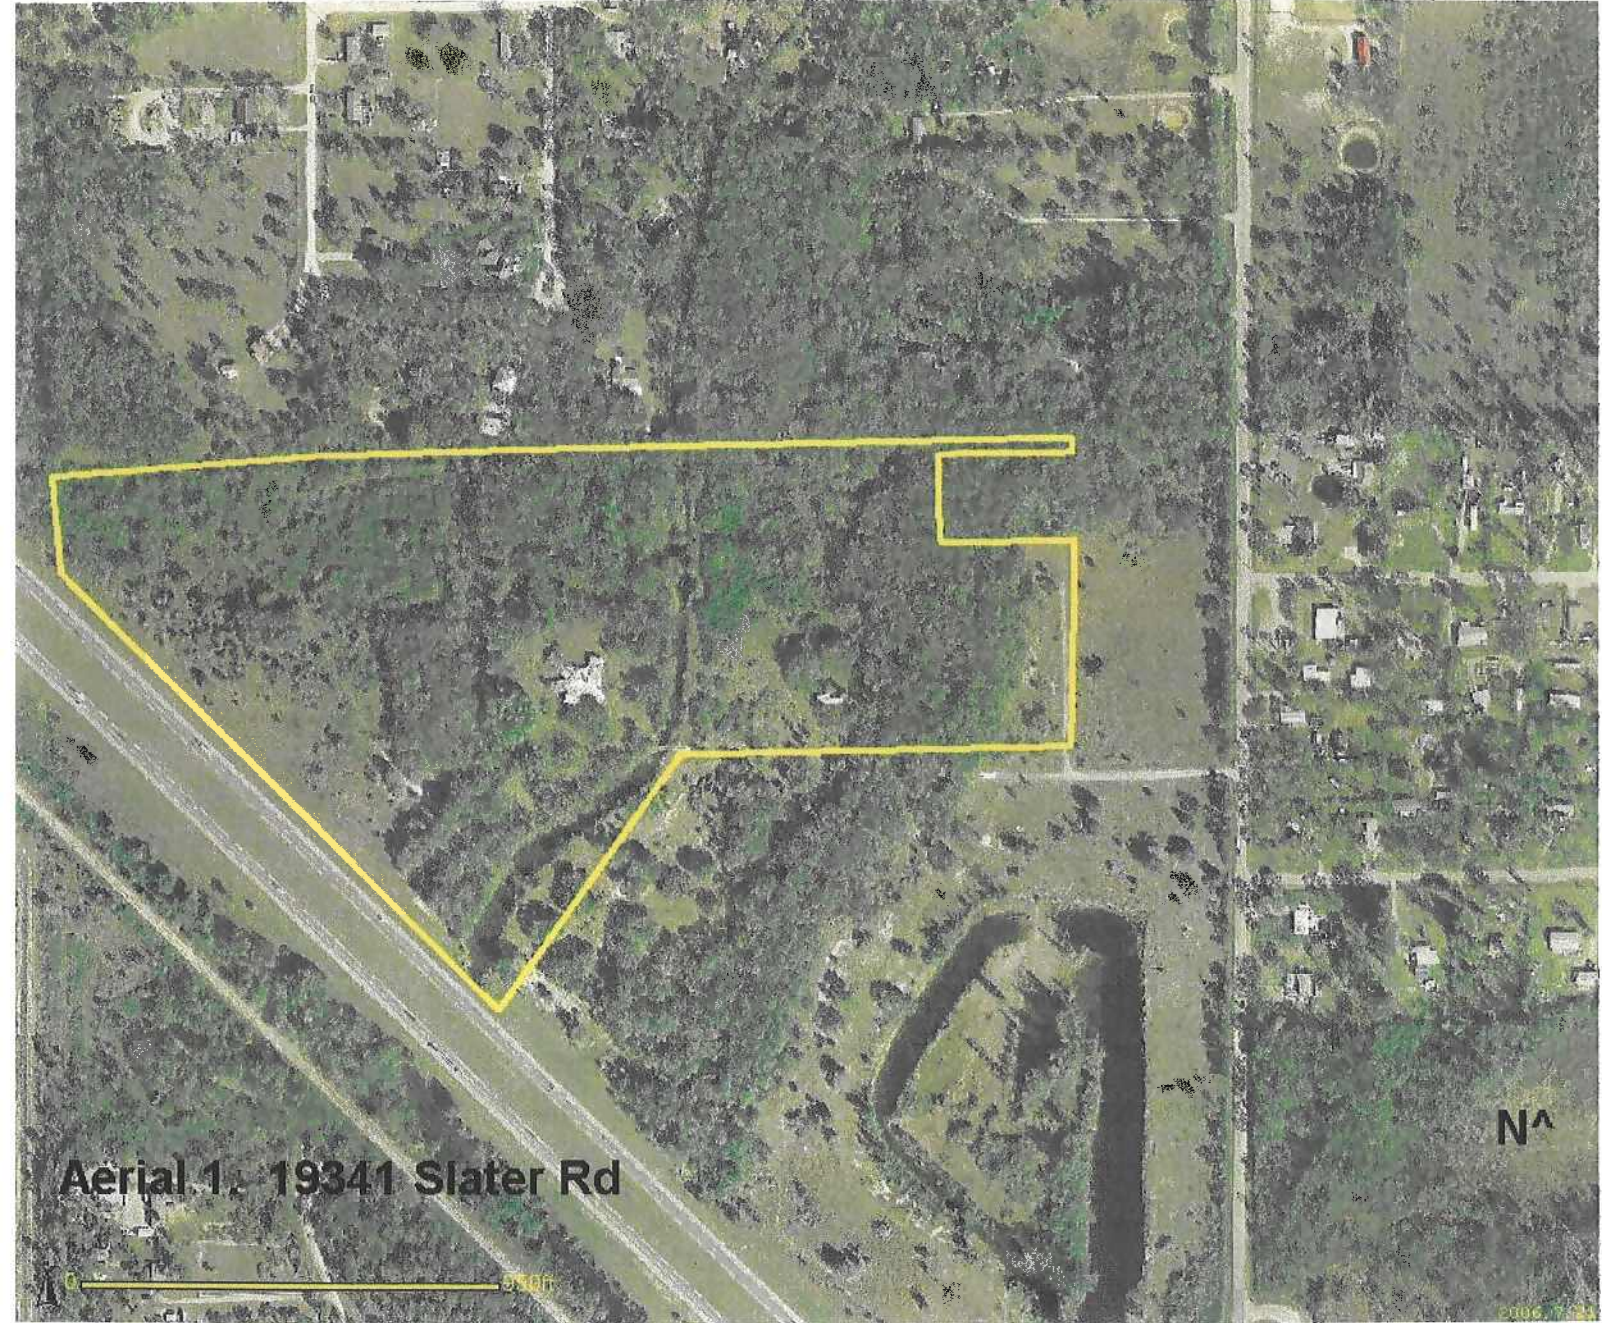
Aerial 1: 19341 Slater Rd

On July 9th and 14th, 2006, Glenn Vaters of Natural Surroundings, LLC inspected 19341 Slater Road, North Fort Myers, Florida, 39317 (Figure 1). The purpose of the inspection was to complete a wetland determination and listed species survey of the 37.57± acre property (Aerial 1).

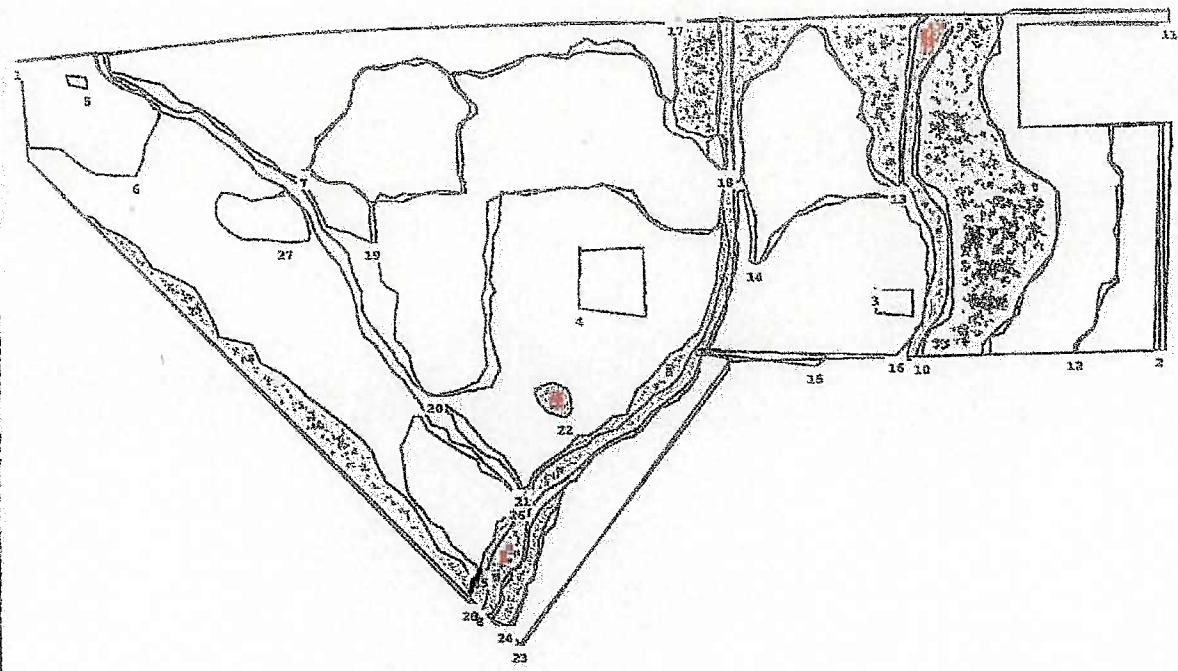
Diagram 1. Wetland Map

Wetlands and "other surface waters" comprise 5.35+ acres of the property and would be considered jurisdictional by both the state South Florida Water Management District (SFWMD) and the federal U.S. Army Corps of Engineers (COE). Any development in these areas would therefore require a state Environmental Resource Permit (ERP), and a federal Dredge and Fill Permit and associated mitigation. The infestation of Brazilian pepper, java plum and other exotics throughout the property has reduced the quality of the wetlands and therefore would reduce the costs of mitigation required as compared to higher quality wetlands.

Any development plan adjacent to the creeks would require at least a 25 foot buffer zone. On-site mitigation is an alternative to purchasing mitigation credits for on-site impacts. The removal and regular re-treatment of the Brazilian pepper and other exotics combined with the planting of native wetland species would result in wetland restoration credit to offset impacts elsewhere on the property. Preservation of some wetlands and the creek buffers through a conservation easement could be incorporated into a development plan.

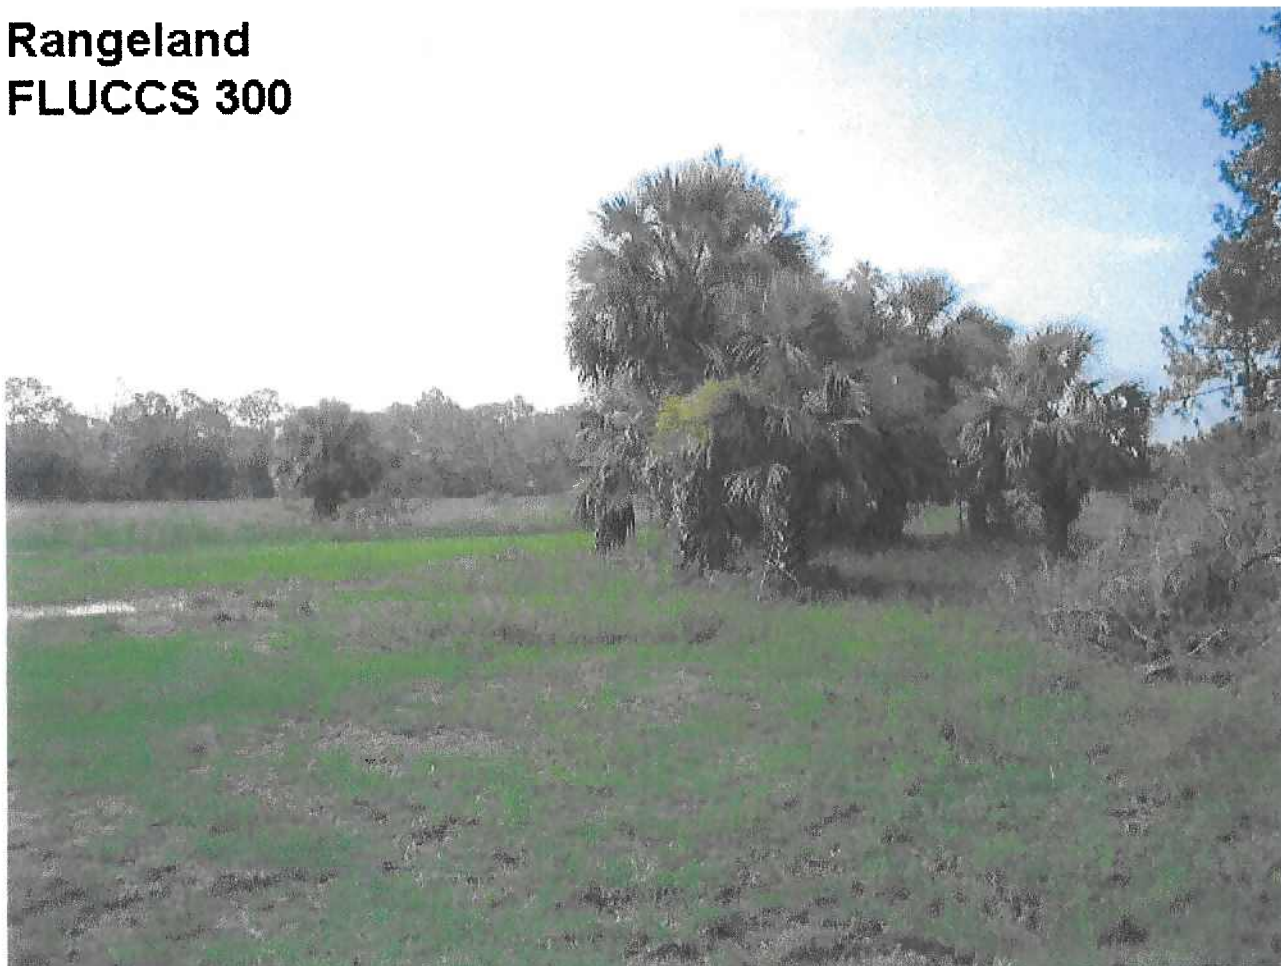
**Rangeland
FLUCCS 300**

This habitat includes all unforested upland areas of the property. It is dominated by pasture grasses such as bahia (*Paspalum notatum*) and disturbed site species such as Caesar weed (*Urena lobata*), crabgrass (*Digitaria* spp.) and blackberry (*Rubus* spp.). It comprises 15.10± acres of the property.

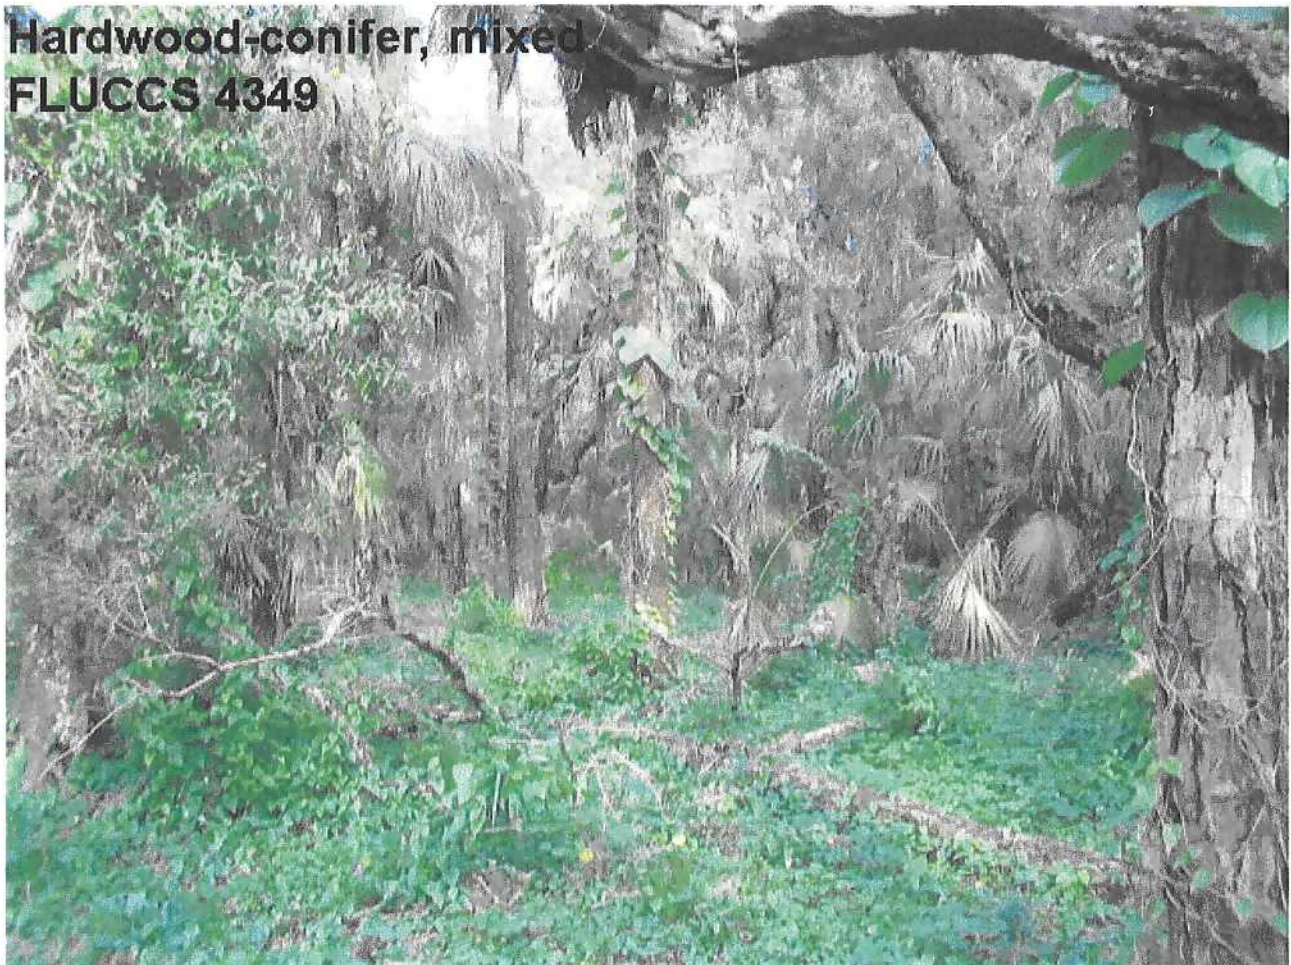
Hardwood-conifer, mixed
FLUCCS 4349

This upland habitat comprises approximately 6.00± acres of the property. It is dominated by live oak, laurel oak, slash pine (*Pinus elliottii*) and cabbage palm. Wax myrtle is a common shrub. Ground cover includes air potato, muscadine grape (*Vitis rotundifolia*), and Caesar weed.

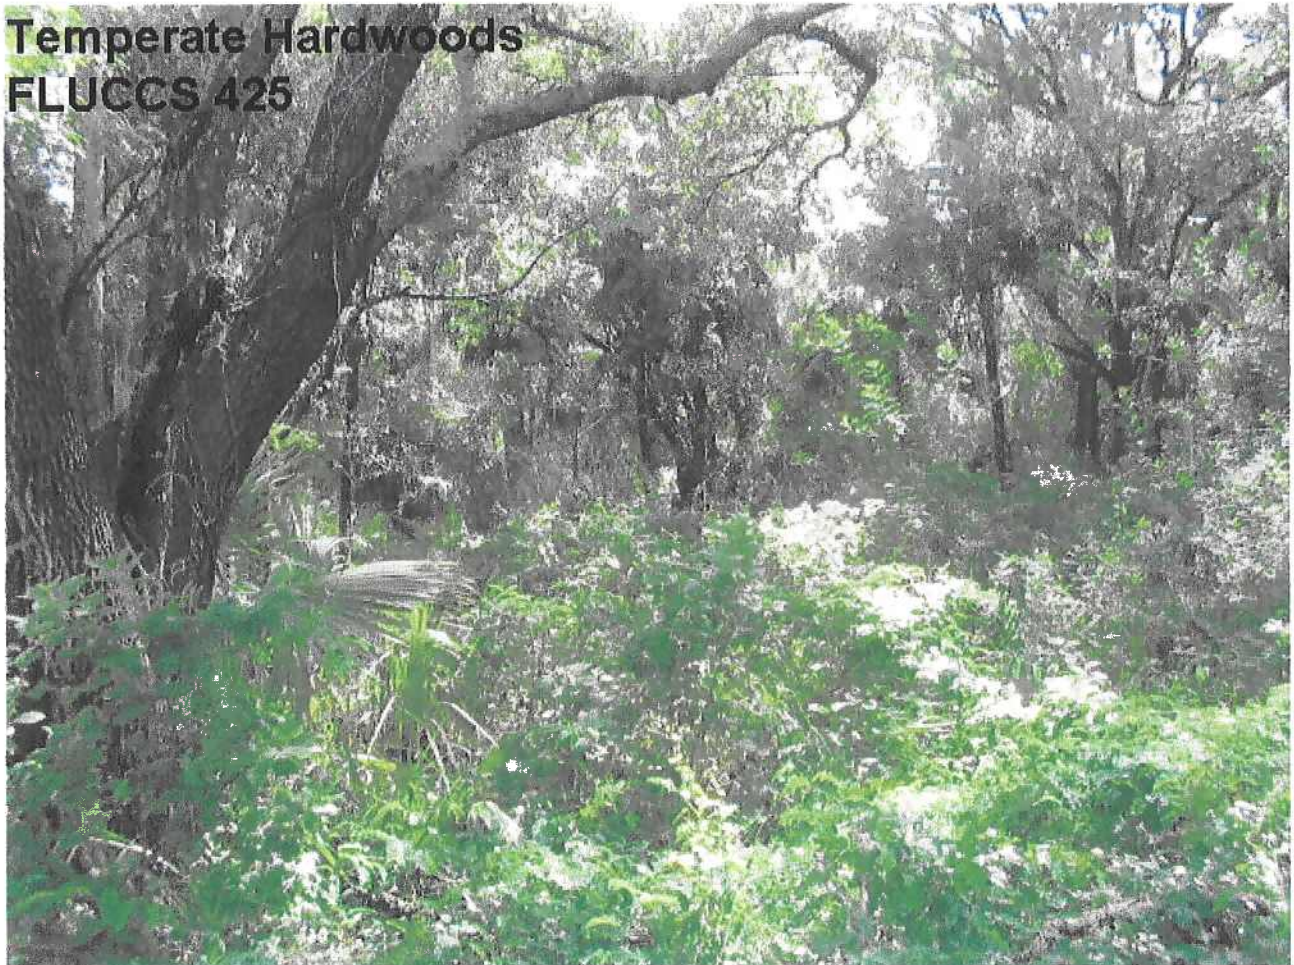
Temperate Hardwoods
FLUCCS 425

This upland habitat comprises 6.65± acres of the property. Dominant native vegetation includes live oak (*Quercus virginiana*) and laurel oak with cabbage palm.

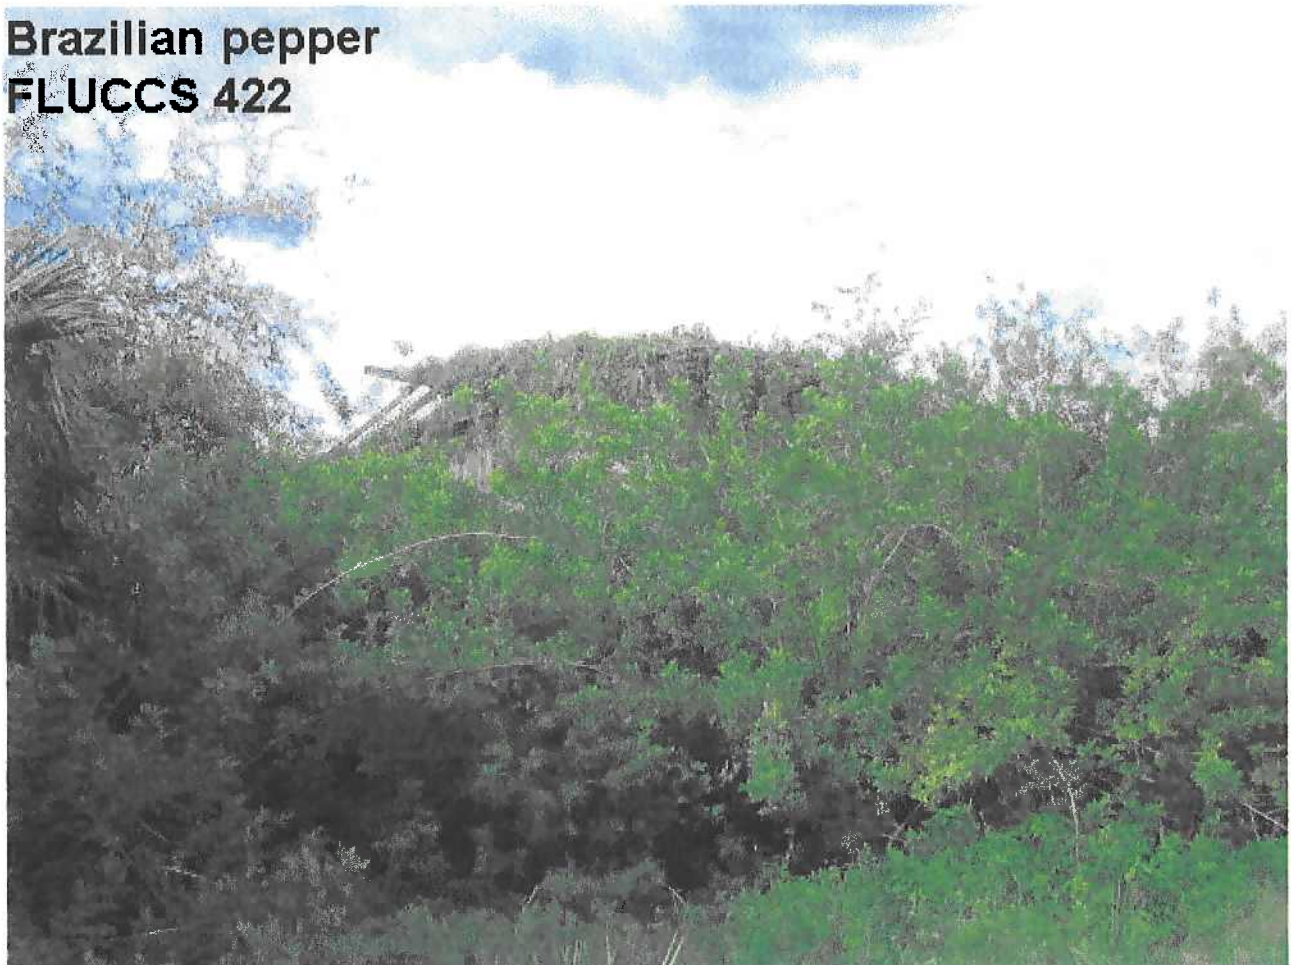
Brazilian pepper
FLUCCS 422

Two large areas of the exotic Brazilian pepper (*Schinus terebinthifolius*) are located on the west side of the property. They comprise 2.59± acres of the property. These areas are so dense with pepper that almost no other species are found within.

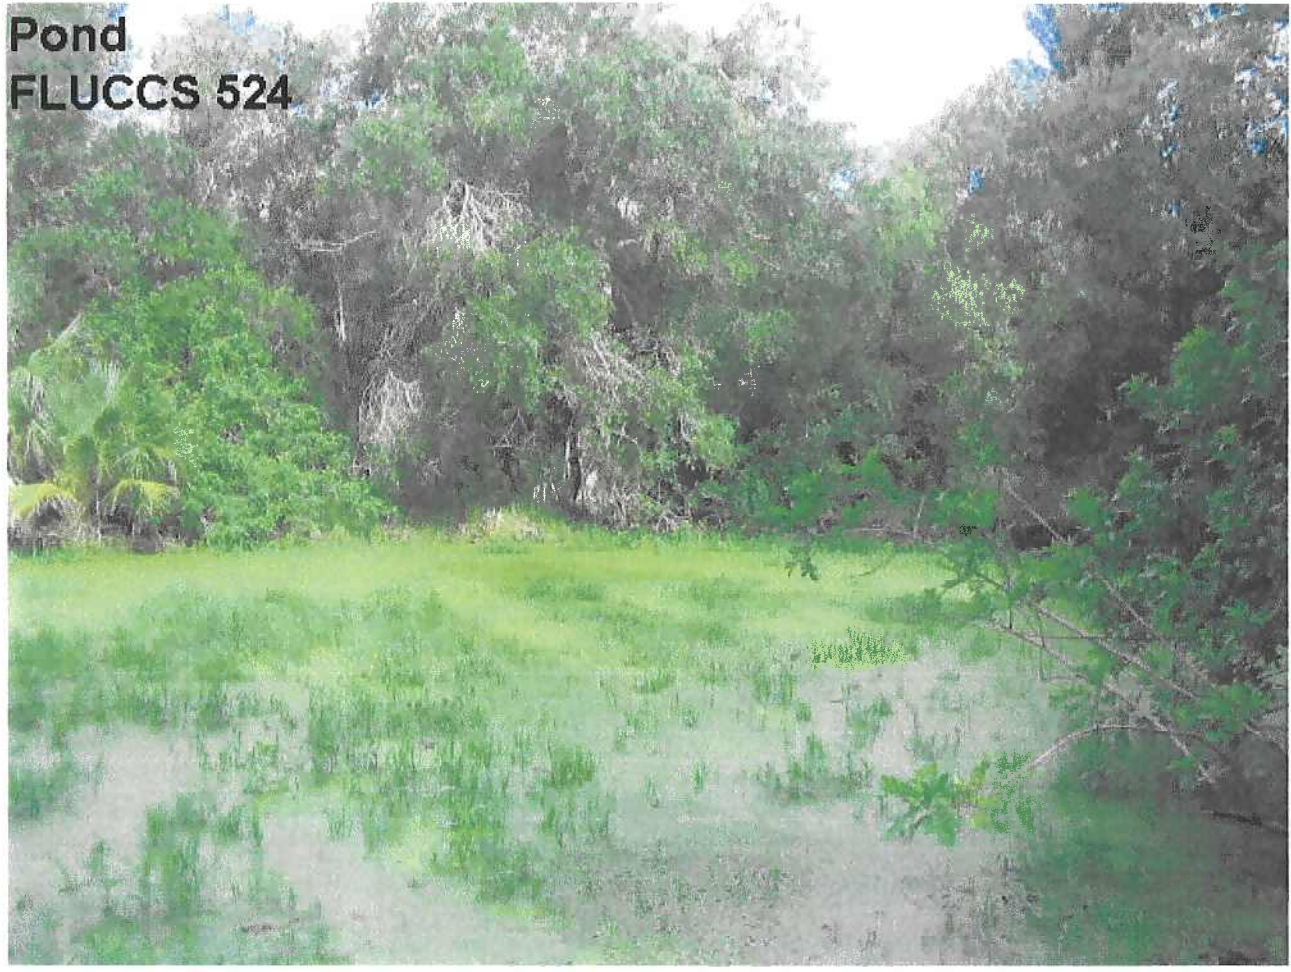
**Pond
FLUCCS 524**

There is a 0.08± acre cow pond south of the main house and west of Daughtrey Creek.

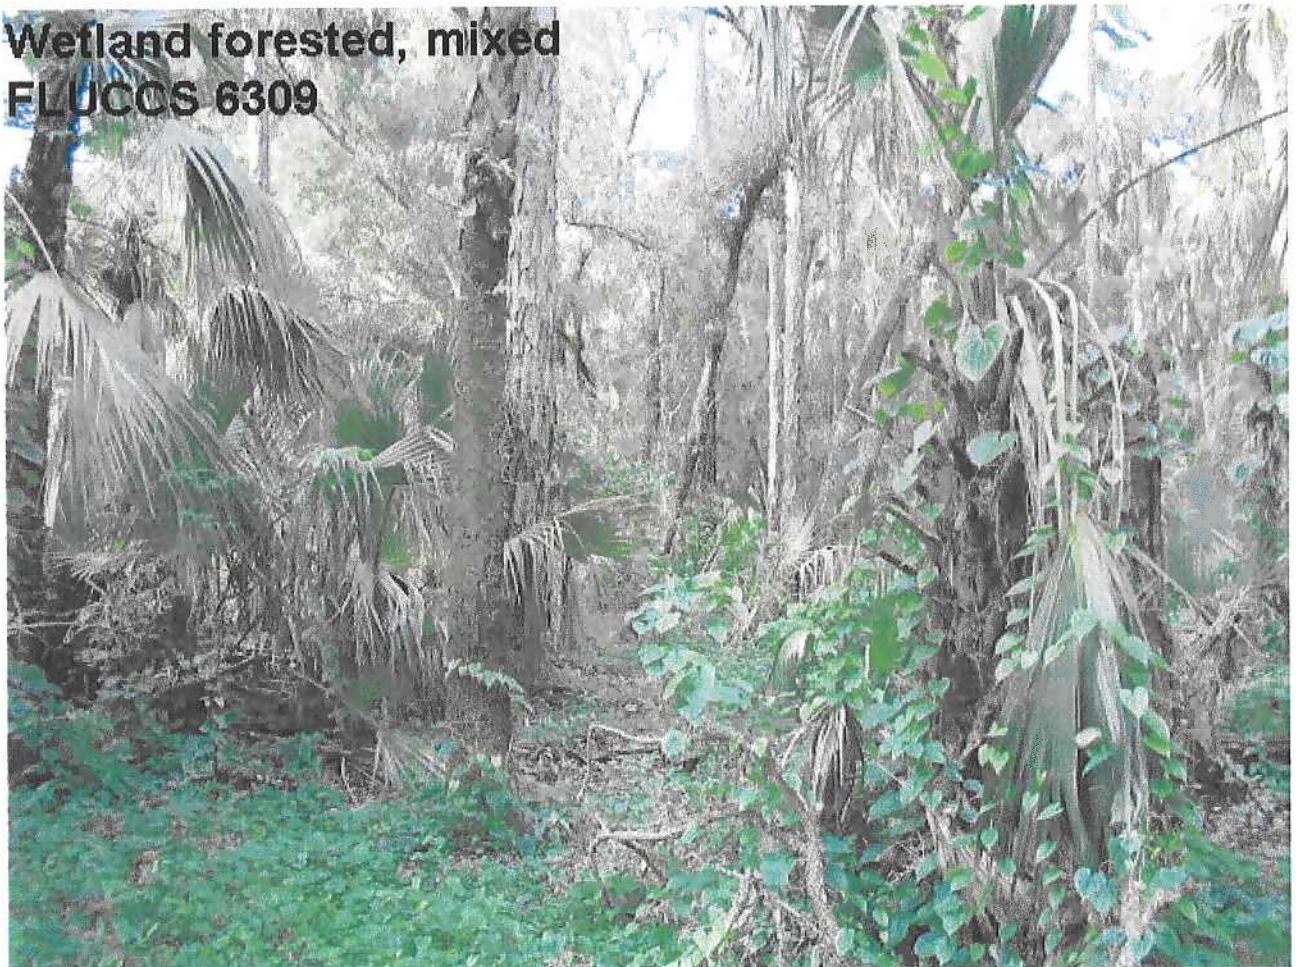
**Wetland forested, mixed
FLUCCS 6309**

This wetland habitat comprises 4.01± acres of the property. Dominant native vegetation includes slash pine (*Pinus elliottii*), laurel oak (*Quercus laurifolia*) and cabbage palm (*Sabal palmetto*). Java plum (*Syzygium* spp.) and air potato (*Dioscorea bulbifera*) are abundant exotics. Other ground cover includes yellow-eyed grass (*Xyris* spp.), swamp fern (*Blechnum serrulatum*), shield fern (*Thelypteris* spp.), maidencane (*Panicum hemitomon*), and rushes (*Juncus* spp.) (see wetland photos).

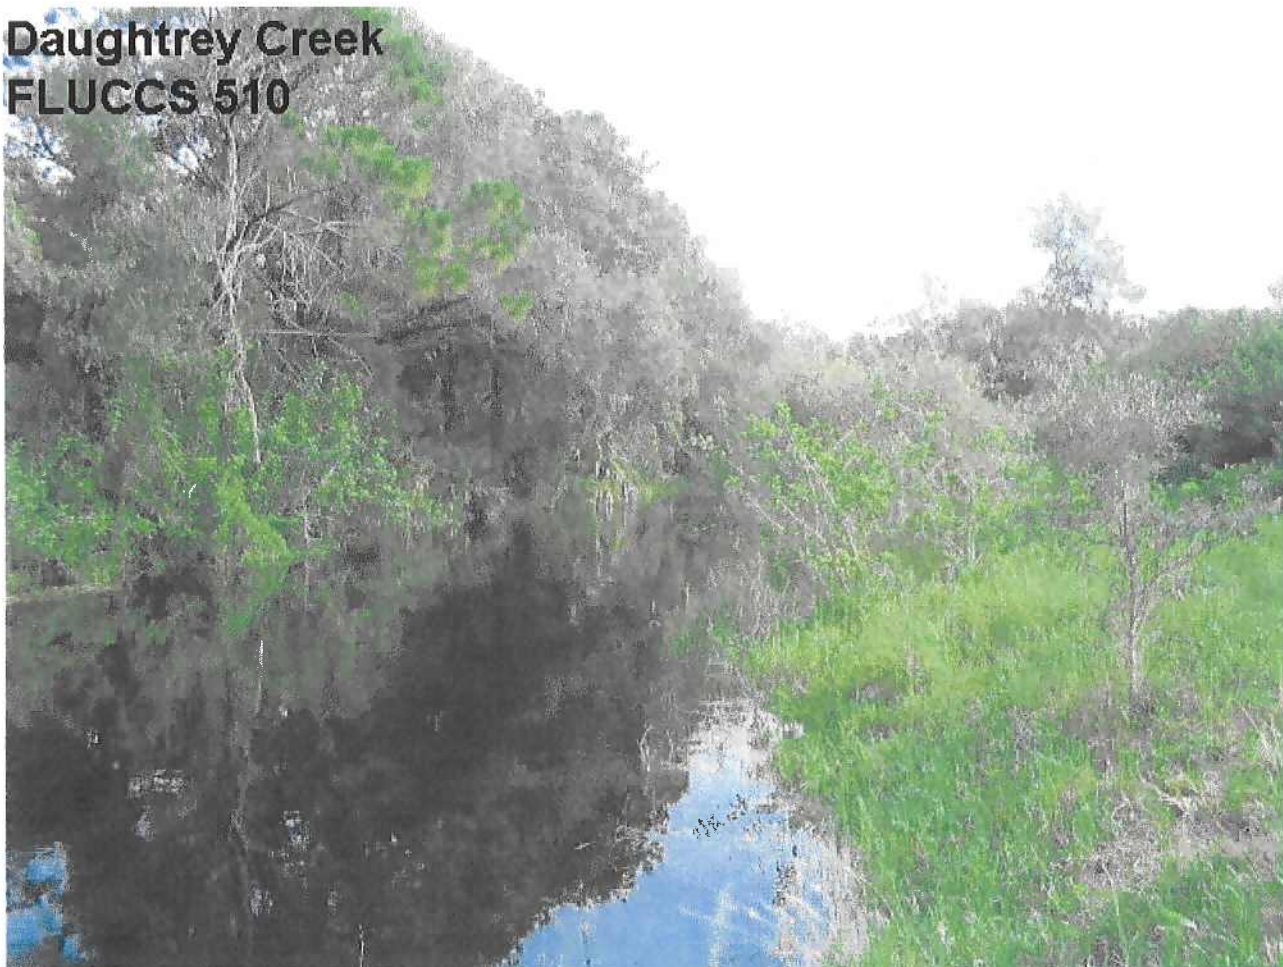
**Daughtrey Creek
FLUCCS 510**

This habitat includes Daughtrey Creek and a smaller creek to the east. They comprise 1.26± acres of the property.

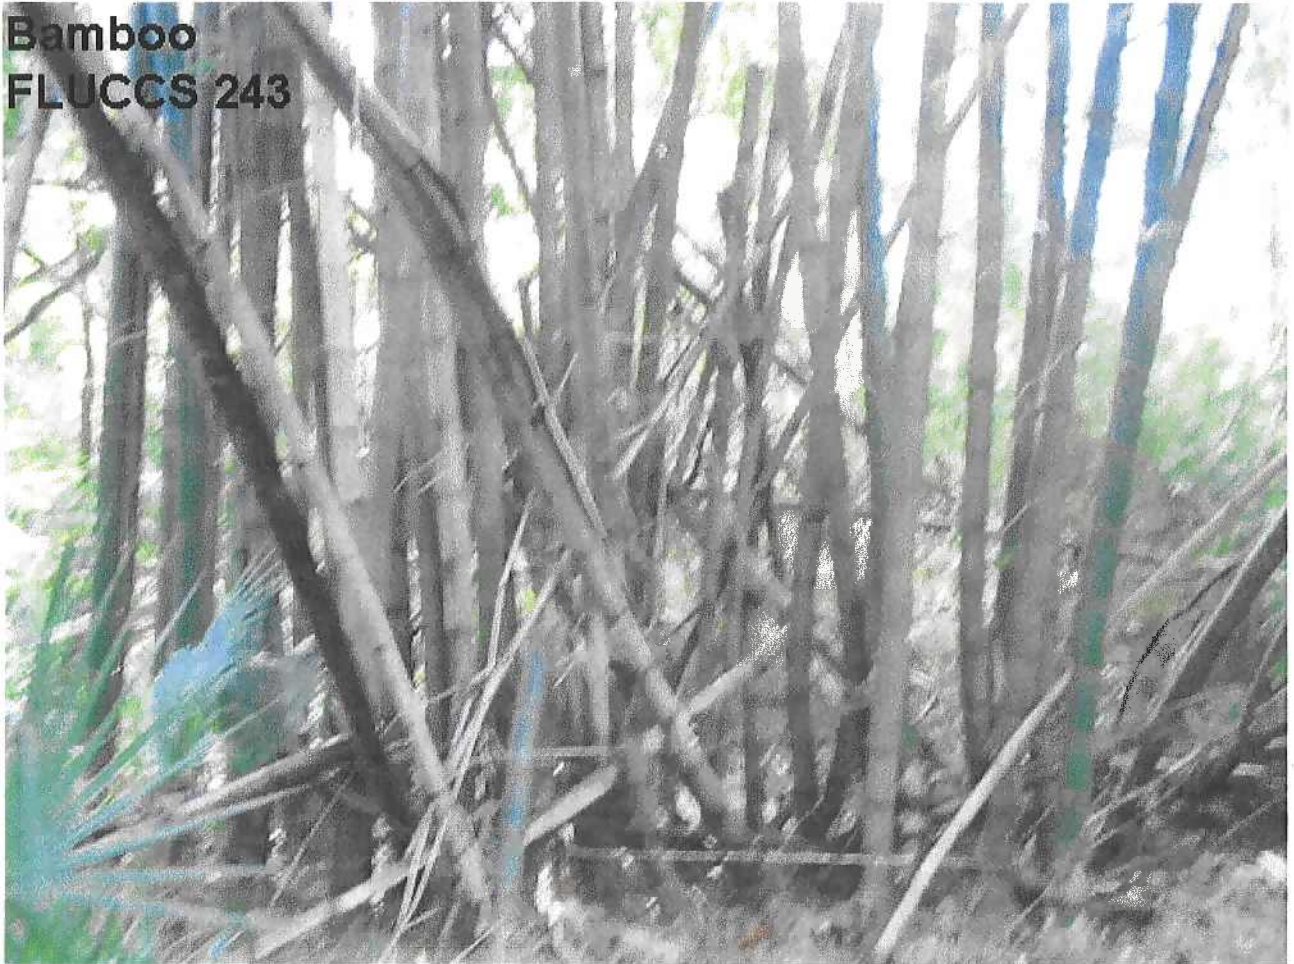
Bamboo
FLUCCS 243

A stand of large bamboo (*Gigantochloa* spp.) can be found on the west side of Daughtrey Creek. It comprises 0.05± acres.
